# Enhancing the Ecological Health of Western Port

Mangrove Planting for Coastal Stabilisation 2010-2013  
Final Report

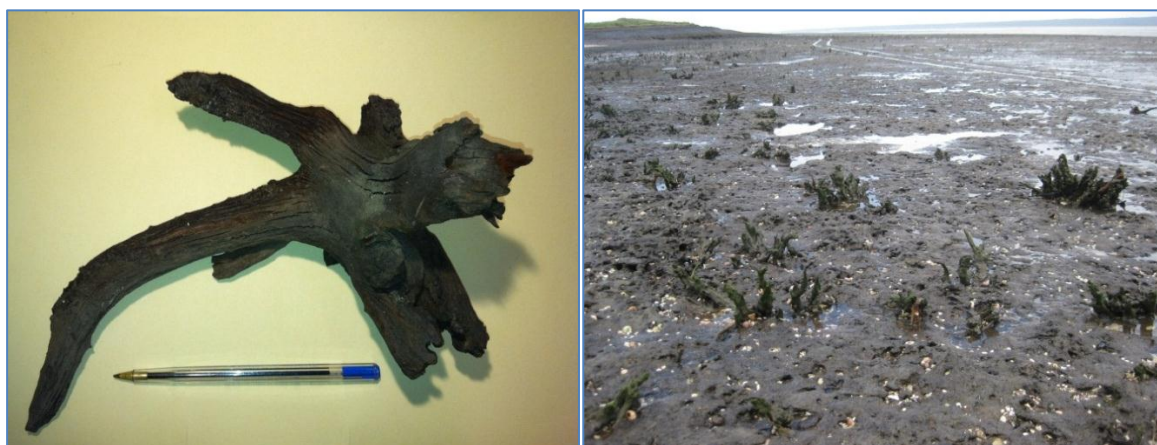
**Figure 9: 10,000 year old mangrove root (left) and site where roots are located along the Lang Lang coast (right).**

Although it appears that mangroves have not existed along the Lang Lang coastline since European colonisation (Smythe, 1842), tree roots can be found protruding from the eroding cliff and mudflat surface (see figure 9). The clustered arrangement of roots indicates that they are the remains of a former

forest at that location. A sample of the roots was sent to the National Herbarium of Victoria for identification and it was confirmed through examination of preserved vascular tissue that they are *Avicennia* roots (Cantrill, 2012). A sample was subsequently sent to the Australian Nuclear Science and Technology Organisation (ANSTO) for radiocarbon dating that estimated that they are 9,695 years old +/- 50yrs. (ANSTO, 2012). Sea-levels at this time were likely to be much lower than they are today and this information may be useful for local geological studies. However, while interesting, the prehistoric existence of mangroves along the Lang Lang coast does not really tell us much about whether they will survive here today.

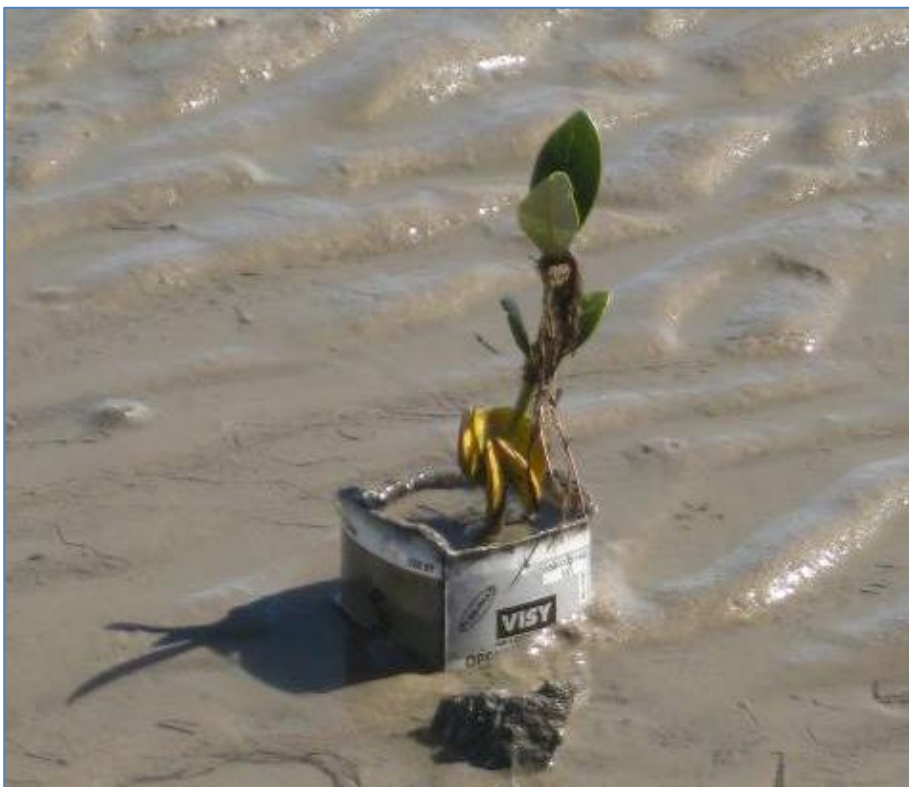
**Figure 12: Mangrove seedling raised in 600ml milk carton planted directly into mud**

The seedling-raising technique originally developed by the WPSP involves planting propagules directly into 600ml milk cartons filled to ~5cm from the top with soil. The milk cartons are a convenient and cheap container that is biodegradable and thought to provide extra stability for young mangroves planted in the mudflats (see Figure 12). This stability is the result of the suction formed by the contact between the waxed side of the carton and the mud. A hole is drilled through the sides of the cartons to allow for root growth and water circulation before being filled with soil. Due to concerns about the cartons resulting in seedlings becoming 'root bound', the nursery investigated alternative containers during the 2012/13 growing season.

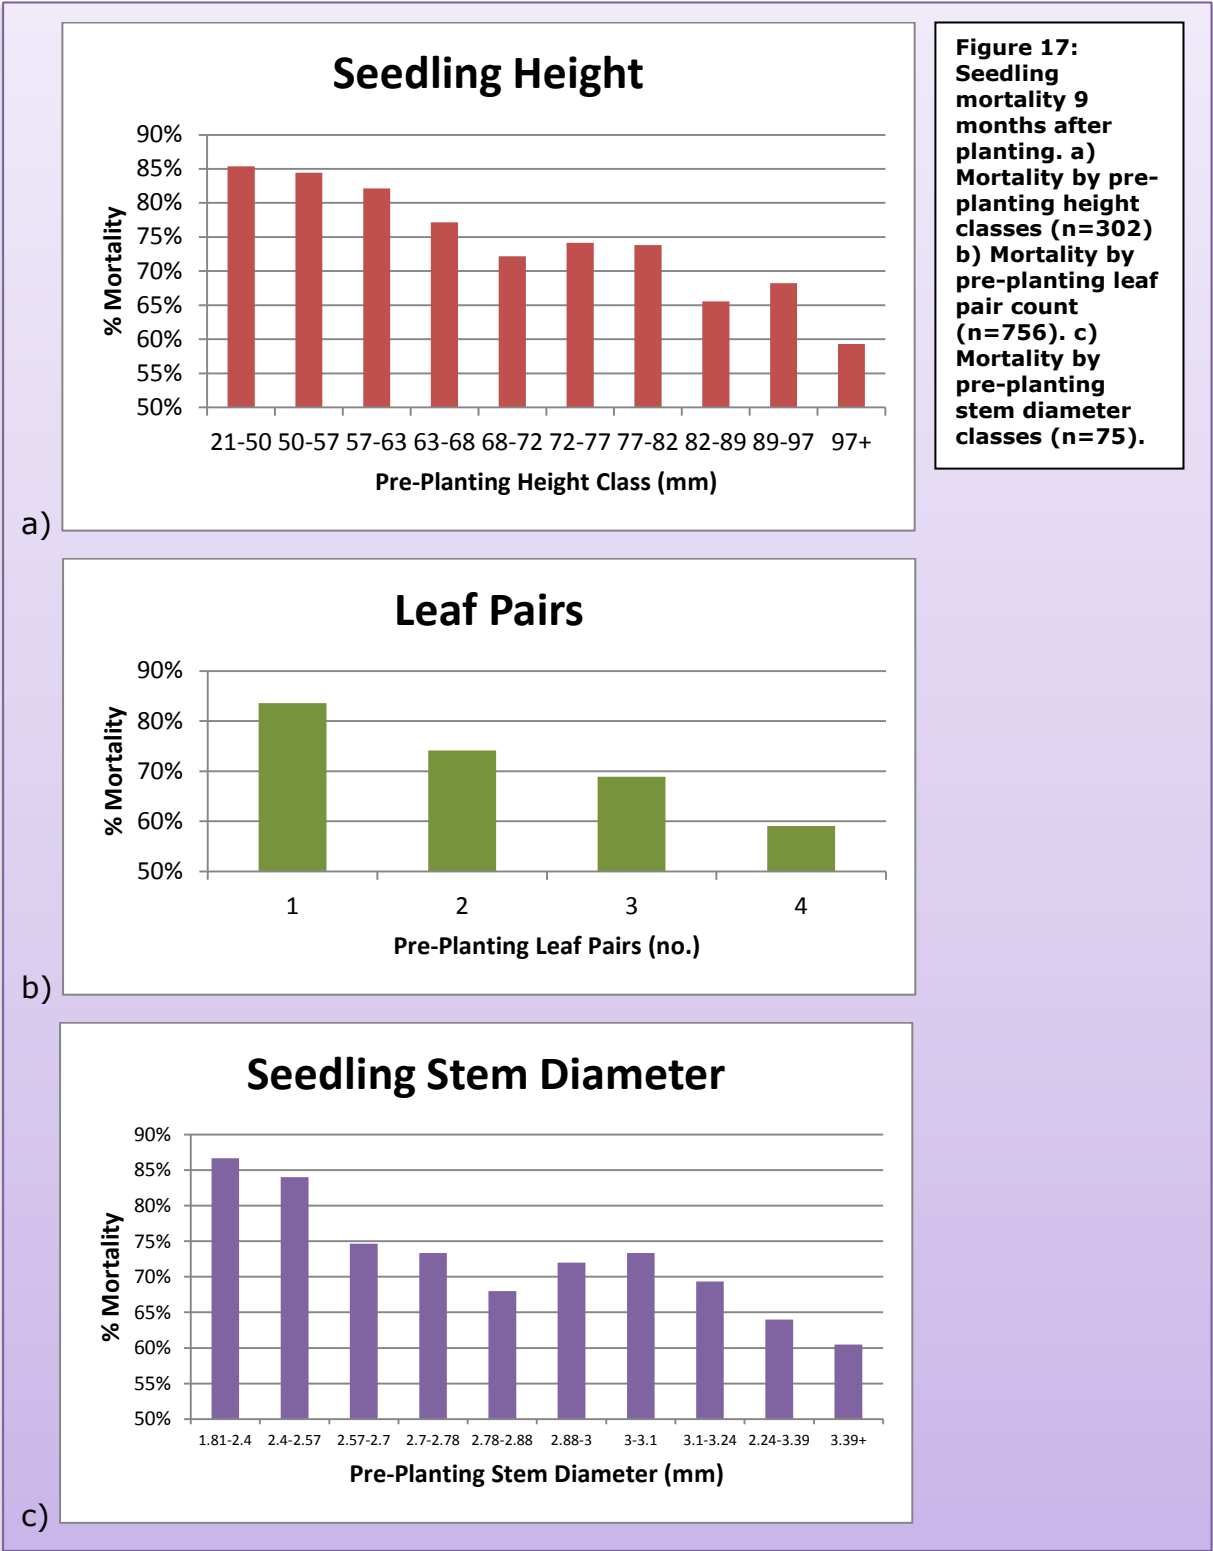
The importance of allowing seedlings to grow as large as possible in the nursery is demonstrated from data collected as part of a concurrent planting experiment that was established in 2011 near Grantville (Figure 17). This experiment is explained further in Box 2, Section 5. Seedlings which were taller, had a greater stem diameter and more pairs of leaves when planted were more likely to survive after planting.

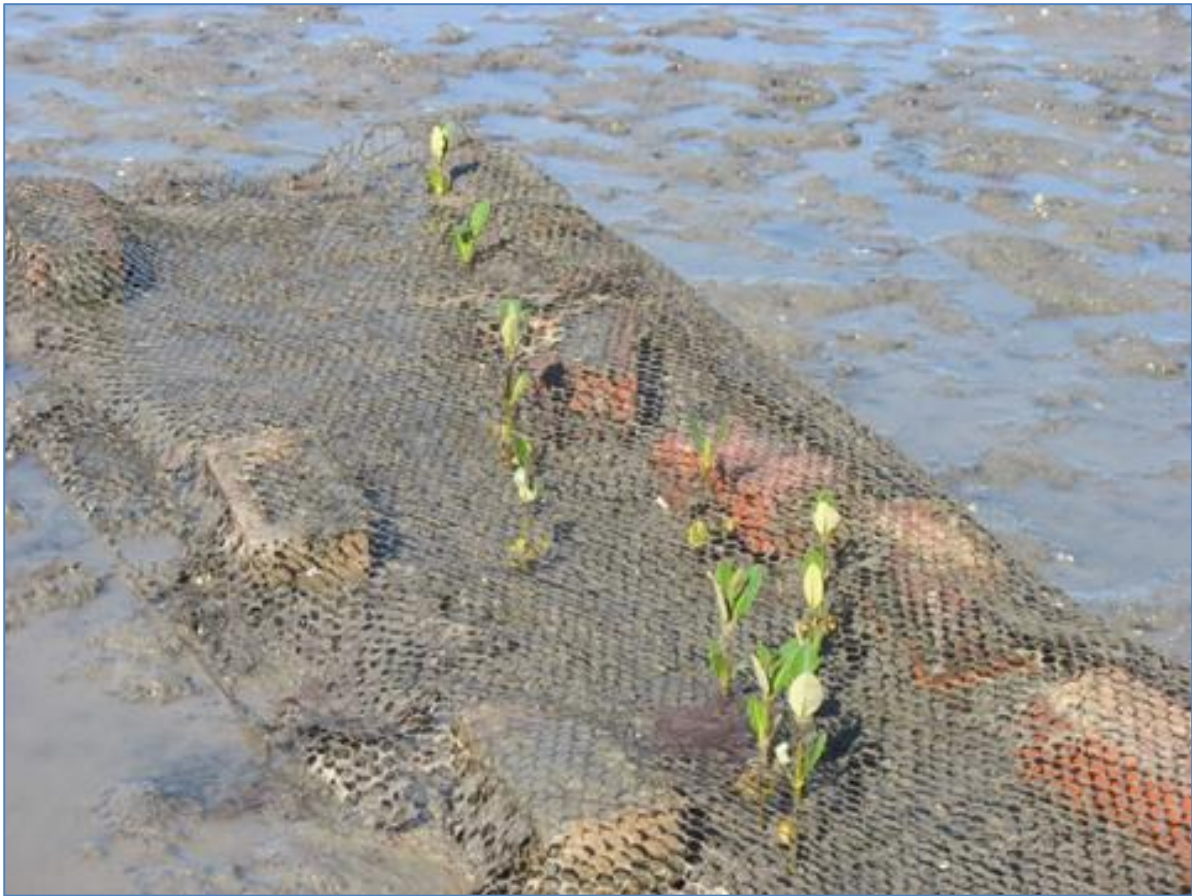
**Figure 27: Crab prevention measure. Mesh is kept above the surface of the mud to prevent crabs from chewing propagules from above the wire.**

Another possibility for the mass failure of seeding was under-ripe propagules, as further direct seeding during January had better success. The extra direct seeding in January was accompanied by some crab prevention measures (see Figure 27). This was briefly successful but the seedlings that had managed to

establish did not survive over the winter and were probably washed out from the soil as a result of localised erosion on the mudflats.

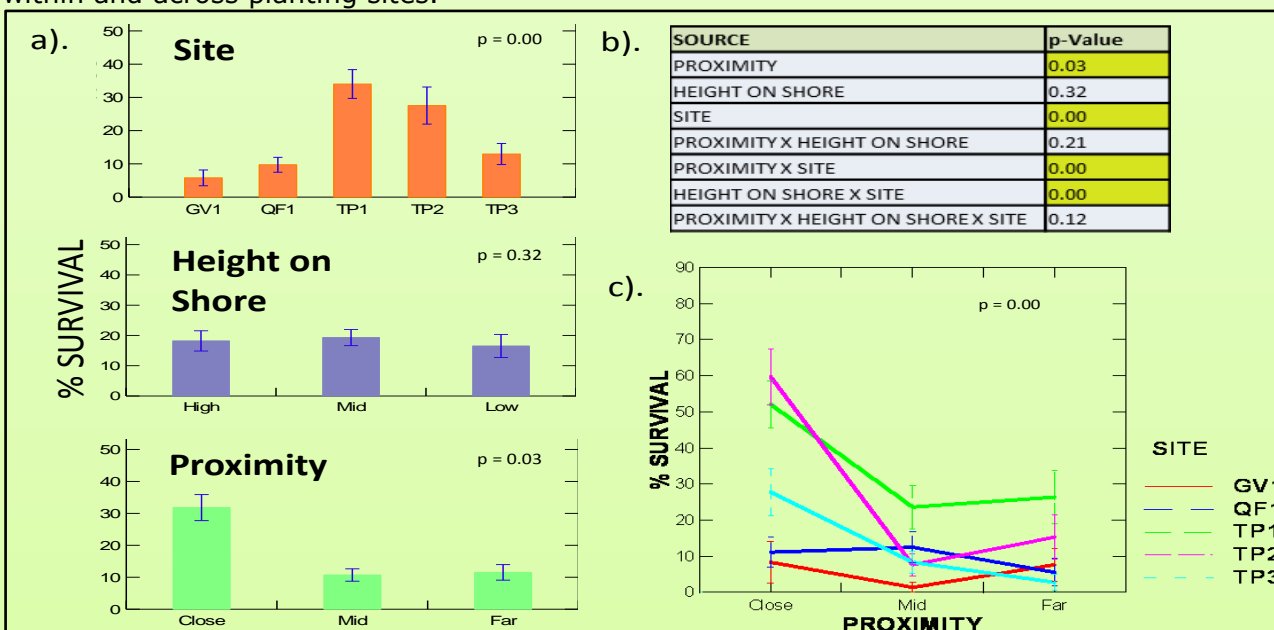
**Figure 32: Survival after 24 months. a) Survival across site, height on shore and proximity treatments, b) Output p-values from 3-way ANOVA (significant results highlighted) and c) Proximity x site interaction plot.**

After 24 months of monitoring, survival of seedlings planted close to remnant forests was three times as high as survival at the other proximities (Figure 32, a)). Additionally, survival varied across sites with the highest survivals found at north facing sites which are more protected from the prevailing westerly weather. High survival at the close proximity was not consistent across sites (c) with the more protected sites mainly responsible for the high survival shown in a). Growth rates were also higher at the north facing sites but height on shore played a greater role in growth than proximity at a site scale. Seedlings are still being monitored but initial analyses indicate that protection is important for the growth and survival of planted mangrove seedlings within and across planting sites.

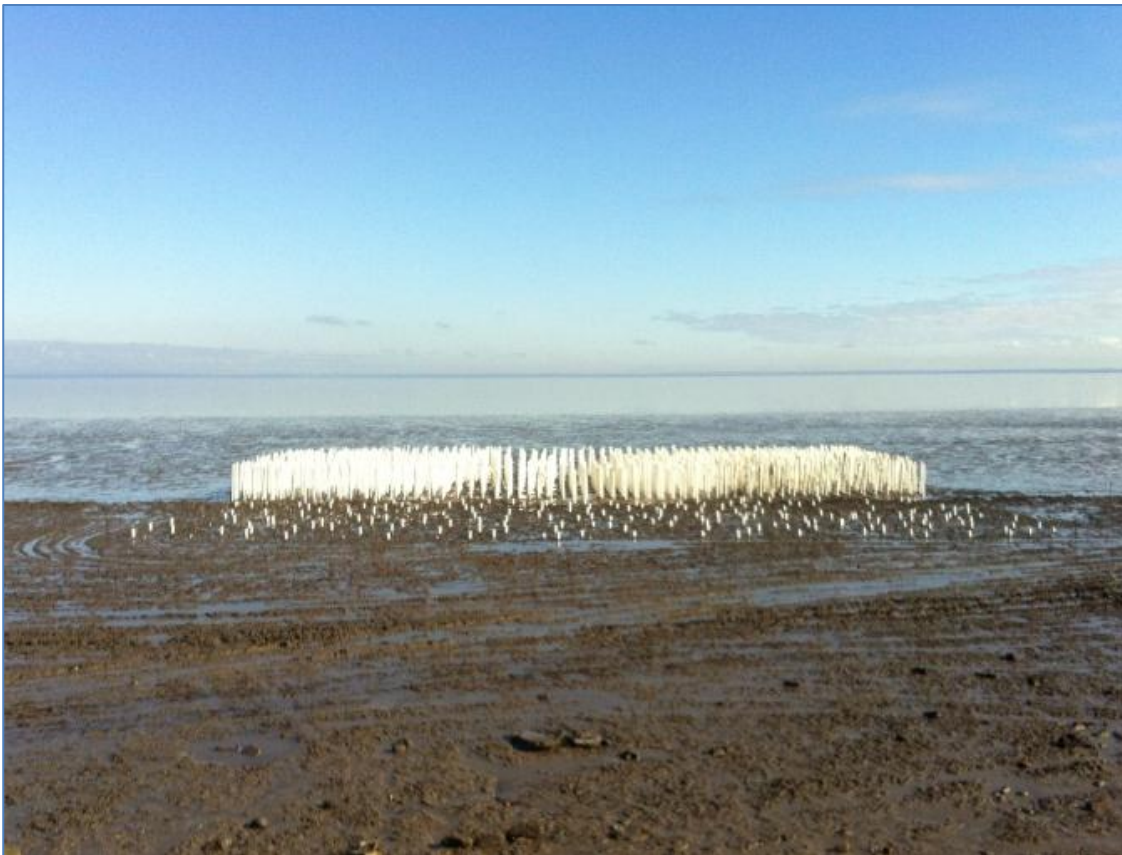
**Figure 33: PVC pipe pile field (with experimental plantings in foreground)**

The pile field wave attenuator is based upon a study which designed an optimal arrangement of vertically driven bamboo piles into the mudflats to reduce incoming wave energy (Halide, Brinkman, & Ridd, 2004). The study found that a pile field that was 30m wide consisting of 80mm piles spaced at

4/m<sup>2</sup> would be effective at attenuating 50% of incoming wave energy. The study also suggested that a minimum of 600mm of each pile should be embedded into the mud. This design was implemented at the Lang Lang coast where three 30m x 15m pile fields were constructed in winter 2013 using 2m lengths of 90mm PVC pipe pushed around one third of their length into the mud (see figure 33). PVC pipe was used as it was the cheapest and most readily available material for pile field construction. Bamboo poles of suitable length and diameter need to be shipped from overseas at a great expense and local natural materials (i.e. tea-tree poles) are not available in the correct dimensions.

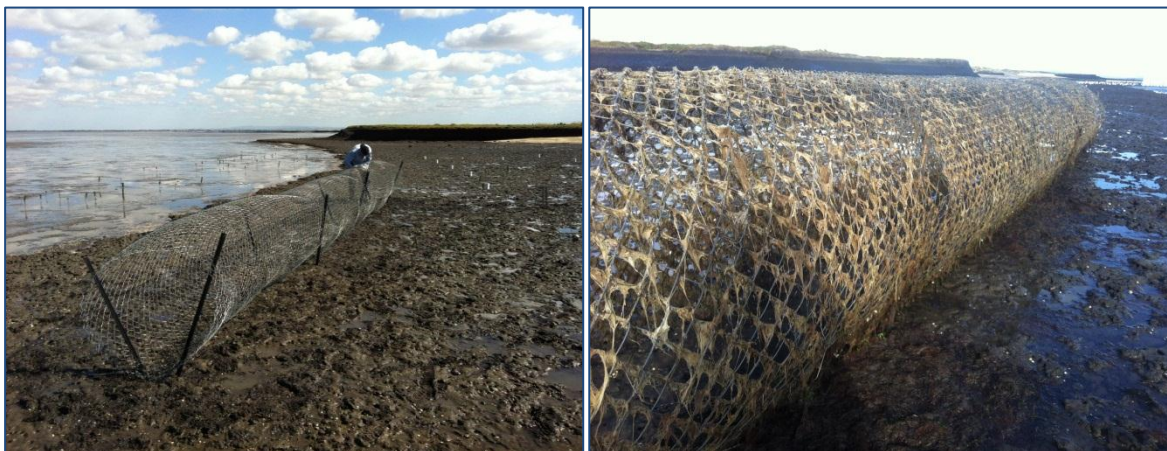
**Figure 34: Enviro roll when constructed (left) and 4 months after construction (right) showing significant build-up of algae and other debris.**

up so that it becomes less 'porous' over time and more effective at attenuating hydrodynamic forces. Three 30m (3 x 10m lengths) Enviro-rolls were constructed in winter 2013 as part of the trial which is described below.

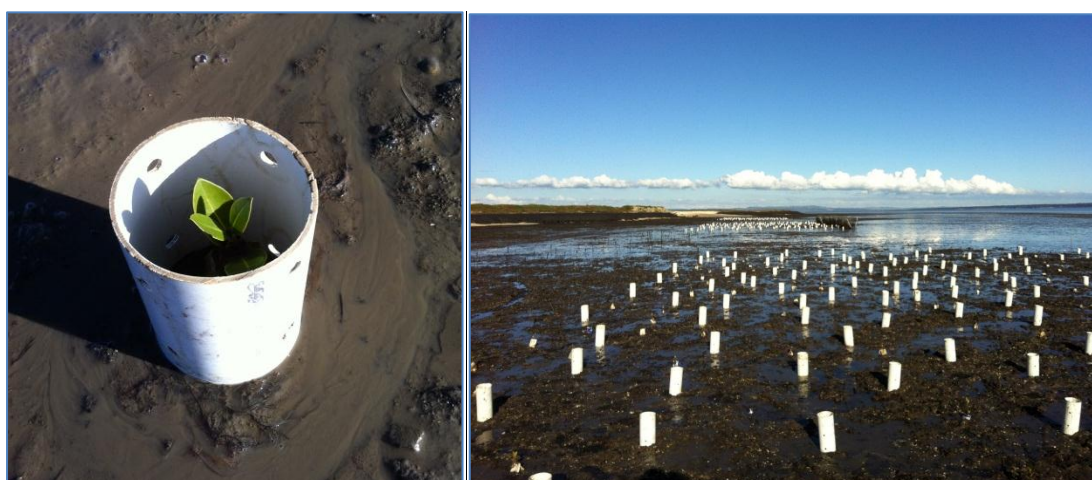
**Figure 35: PVC pipe tree guard (left) randomly placed in experimental plots (right)**

The final wave attenuation measure that was trialled was PVC pipe tree-guards. This technique is a modified version of the Riley-Encasement Method (REM) where a single mangrove seedling is raised in a length of PVC pipe which provides stem protection and promotes growth through phototropism (stimulation of growth towards light source) (Riley & Kent, 1999). The PVC pipe tree guard method aims to provide similar protective properties to REM but differs in that a 400mm piece of 100mm diameter pipe is fitted over an already planted seedling. The guard is pushed 100-200mm in the mud around the seedling and has been pre drilled to allow water to drain from the guard at low tide (see Figure 35).

The tree-guard aims to provide protection for the seedling in its early growth phases and may also help to reduce local erosion around the plants which has been undermining some seedlings at Lang Lang. It is not anticipated that trees will outgrow the guards for many years but they should be monitored to determine when the guards need to be removed. A biodegradable version of these guards made of rice husks has been developed and are being used for mangrove revegetation in Singapore and may be suitable for use in Western Port (Anon, 2013).

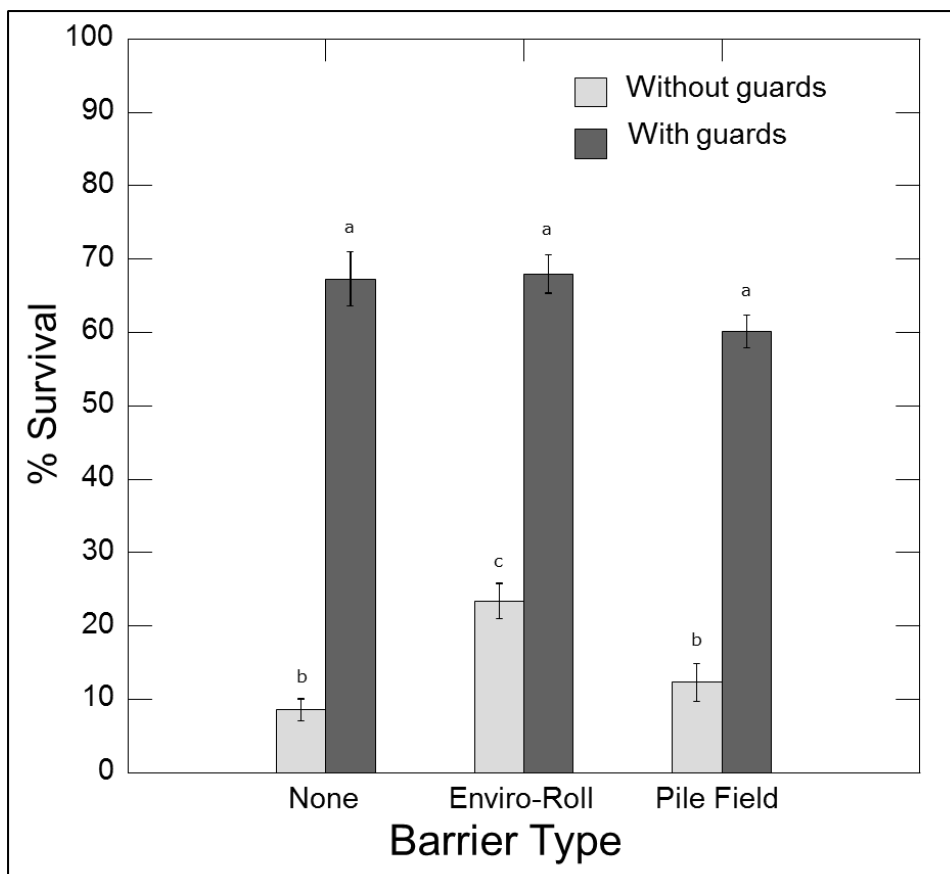
**Figure 38: Seedling survival by barrier type and presence of PVC tree-guards. Error bars shown are  $\pm 1$  SE. Treatments with same letter are not significantly different.**

Five months after planting, seedlings which had been protected with a PVC tree guard displayed an average 65% survival rate (no barrier 67%, Enviro-Roll 68%, Pile Field 60%) whereas an average of only 15% of seedlings that did not have a tree-guard were surviving (no barrier 8%, Enviro-Roll 23%, Pile Field 12%). Guarded seedling survival was not significantly different between barrier type, however it was slightly lower for the pile fields. This may have been caused by the disturbance to the planting plots that was a
